**Flood Control Project Maintenance  
Levee Inspections**

**Fall 2019 Levee Maintenance Deficiency Summary Report**

**Sacramento River Basin**

**Sacramento Maintenance Yard Maintenance Area 0009**

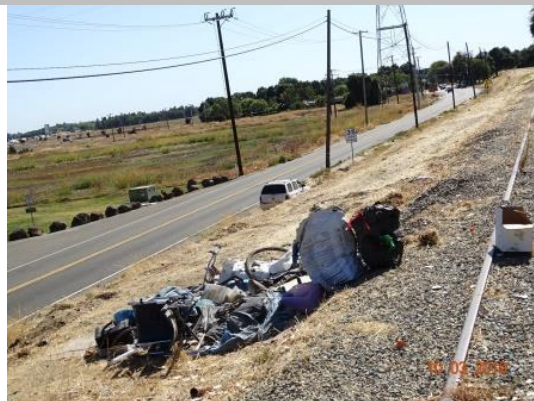
Photo 1 of 2 : FA\_2019\_MA0009\_201\_248\_20191008\_00538.jpg

LM Start	8.79	Rating **	M	Issue No.	248
LM End	8.79	Issue Type +	Ma	Location *	LS
Category	Earthen Levee			GPS Latitude/Longitude	
				Start	End
Item	Encroachments			38.469418 °	38.469418 °
				-121.503565 °	-121.503565 °
DWR ID	DWR_MA0009_01_f_2019_248				
Comment Code					
DE : Debris					
Inspector Comment					
Remove debris on the levee crown and at waterside toe.

View of homeless debris on the landside slope. Fall 2019

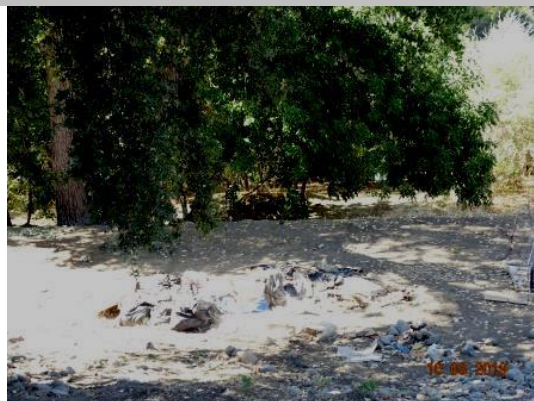
Photo 2 of 2 : FA\_2019\_MA0009\_201\_248\_20191008\_00539.jpg

View of homeless debris at the waterside toe. Fall 2019

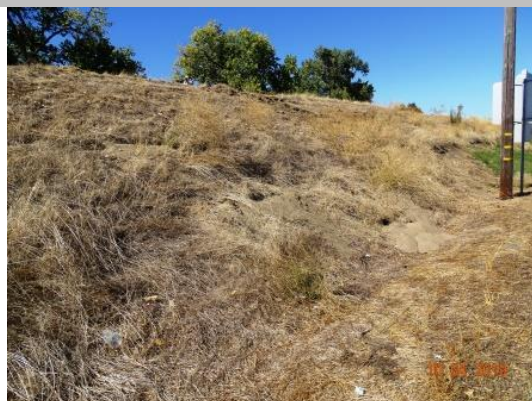
Photo 1 of 2 : FA\_2019\_MA0009\_201\_377\_20191010\_00550.jpg

LM Start	8.81	Rating **	U	Issue No.	377
LM End	8.81	Issue Type +	Ma	Location *	LS
Category	Earthen Levee			GPS Latitude/Longitude	
				Start	End
Item	Animal Control			38.469185 °	38.469185 °
				-121.503337 °	-121.503337 °
DWR ID	DWR_MA0009_01_f_2019_377				
Comment Code					
A1 : Exterminate rodents and backfill and compact or grout burrows.					
Inspector Comment

View of several rodent holes with recent activity. Fall 2019

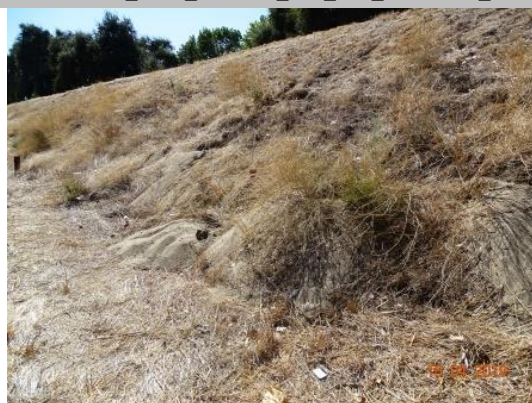
Photo 2 of 2 : FA\_2019\_MA0009\_201\_377\_20191010\_00551.jpg

View of several rodent holes with recent activity. Fall 2019

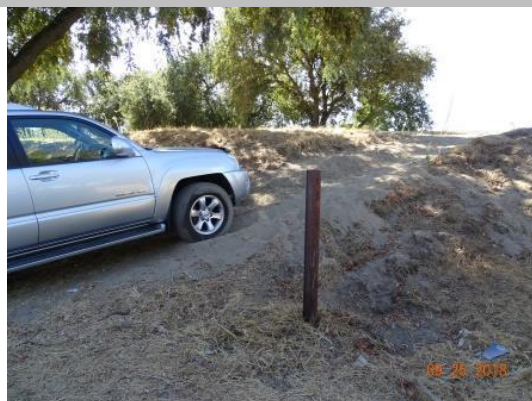
Photo 1 of 2 : FA\_2019\_MA0009\_201\_346\_20190904\_00248.jpg

LM Start	9.08	Rating **	M	Issue No.	346
LM End	9.08	Issue Type +	Ma	Location *	LS
Category	Earthen Levee			GPS Latitude/Longitude	
				Start	End
Item	Slope Stability			38.465278 °	38.465278 °
				-121.503210 °	-121.503210 °
DWR ID	DWR_MA0009_01_f_2019_346				
Comment Code					
S3 : Repair the levee slope damaged by vehicle traffic and prevent access where possible.					
Inspector Comment					
Recommend placing a gate at this popular site.

View of slope damage caused by vehicle and foot traffic. Fall 2018

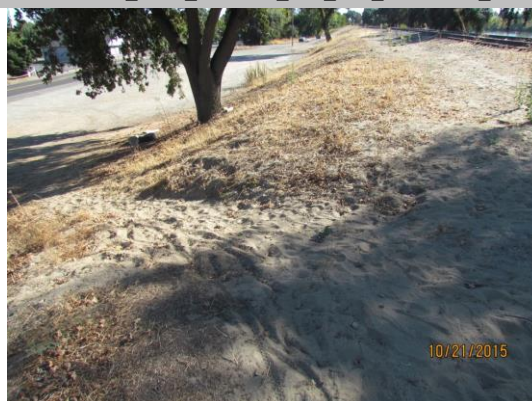
Photo 2 of 2 : FA\_2019\_MA0009\_201\_346\_20190904\_00249.jpg

View of the slope stability issue caused by foot traffic on the landward side of the levee looking downstream. Fall 2015.

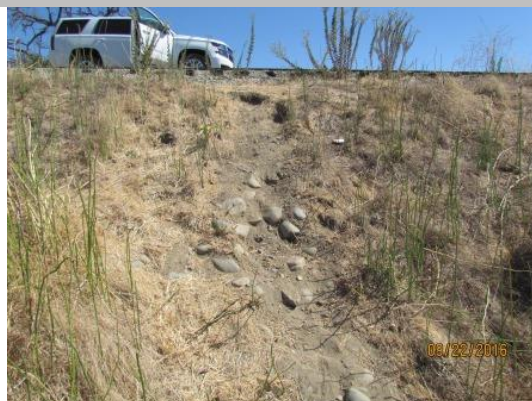
Photo 1 of 1 : FA\_2019\_MA0009\_201\_253\_20190904\_00179.jpg

LM Start	9.22	Rating **	A/W	Issue No.	253
LM End	9.22	Issue Type +	Ma	Location *	WS
Category	Earthen Levee			GPS Latitude/Longitude	
				Start	End
Item	Slope Stability			38.463301 °	38.463301 °
				-121.502904 °	-121.502904 °
DWR ID	DWR_MA0009_01_f_2016_253				
Comment Code					
S2 : Repair the levee slope damaged by foot traffic and prevent access where possible.					
Inspector Comment

View of a footpath on LS slope causing slope stability issue. Fall 2016.

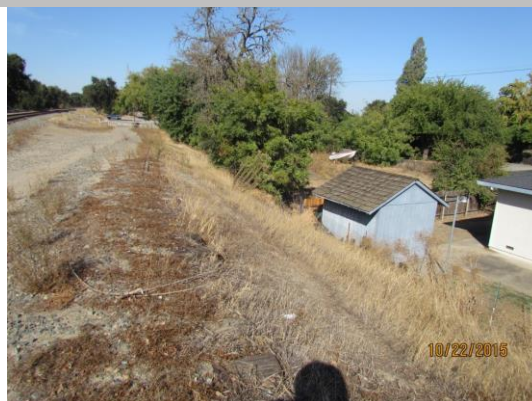
Photo 1 of 1 : FA\_2019\_MA0009\_201\_168\_20190904\_00094.jpg

LM Start	9.23	Rating **	M	Issue No.	168
LM End	9.23	Issue Type +	En	Location *	LS
Category	Earthen Levee			GPS Latitude/Longitude	
				Start	End
Item	Encroachments			38.463138 °	38.463138 °
				-121.502788 °	-121.502788 °
DWR ID	DWR_MA0009_01_s_2012_168				
Comment Code					
BU : Building					
Inspector Comment

View of the building at the toe of the landward side of the levee looking upstream. Fall 2015.

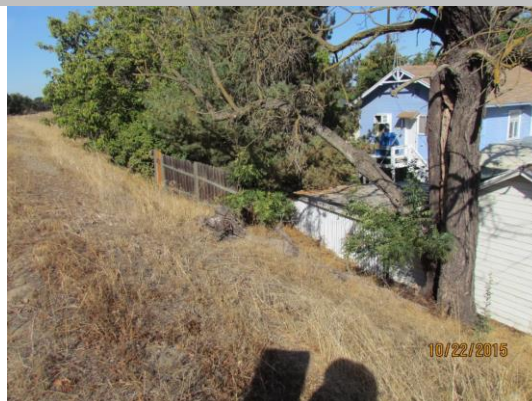
Photo 1 of 2 : FA\_2019\_MA0009\_201\_169\_20190904\_00095.jpg

LM Start	9.25	Rating **	U	Issue No.	169
LM End	9.25	Issue Type +	En	Location *	LS
Category	Earthen Levee			GPS Latitude/Longitude	
				Start	End
Item	Encroachments			38.462900 °	38.462900 °
				-121.502762 °	-121.502762 °
DWR ID	DWR_MA0009_01_s_2012_169				
Comment Code					
FE : Fence					
Inspector Comment

View of the wooden fence and building on the landward side of the levee looking upstream. Fall 2015.

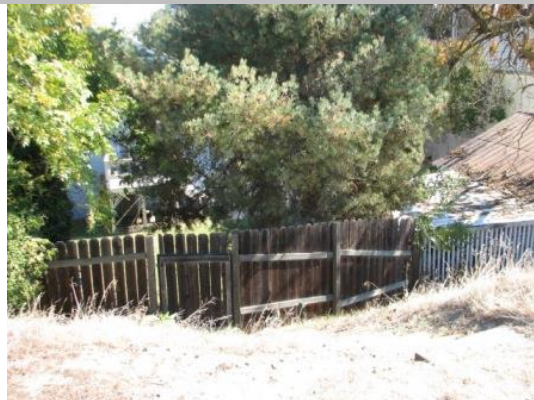
Photo 2 of 2 : FA\_2019\_MA0009\_201\_169\_20190904\_00096.jpg

LM Start	9.25	Rating **	U	Issue No.	169 (cont)	
LM End	9.25	Issue Type +	En	Location *	LS	
Category	Earthen Levee			GPS Latitude/Longitude		
				Start	End	
Item	Encroachments			38.462900 °	38.462900 °	
				-121.502762 °	-121.502762 °	
DWR ID	DWR_MA0009_01_s_2012_169					
Comment Code						
FE : Fence						
Inspector Comment

A solid wooden fence and building within the easement. Fall 2013

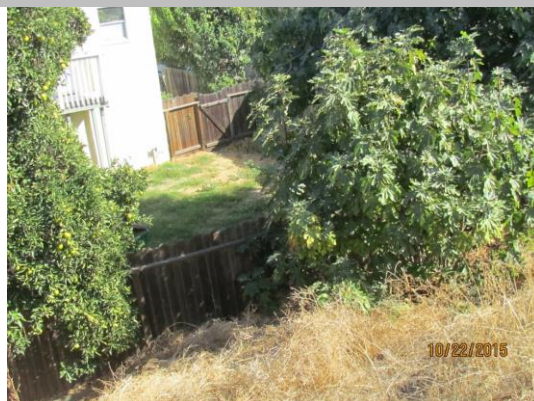
Photo 1 of 1 : FA\_2019\_MA0009\_201\_331\_20190904\_00231.jpg

LM Start	9.25	Rating **	U	Issue No.	331
LM End	9.25	Issue Type +	En	Location *	LS
Category	Earthen Levee			GPS Latitude/Longitude	
				Start	End
Item	Encroachments			38.462802 °	38.462802 °
				-121.502728 °	-121.502728 °
DWR ID	DWR_MA0009_01_f_2013_331				
Comment Code					
FE : Fence					
Inspector Comment

View of the fence and landscape at the toe of the levee on the landward side. Fall 2015.

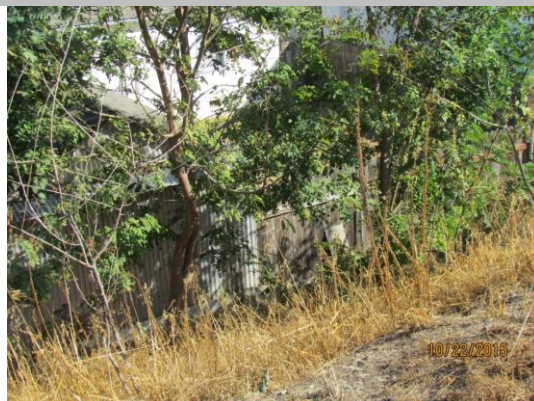
Photo 1 of 2 : FA\_2019\_MA0009\_201\_170\_20190904\_00097.jpg

LM Start	9.26	Rating **	M	Issue No.	170
LM End	9.26	Issue Type +	En	Location *	LS
Category	Earthen Levee			GPS Latitude/Longitude	
				Start	End
Item	Encroachments			38.462653 °	38.462653 °
				-121.502670 °	-121.502670 °
DWR ID	DWR_MA0009_01_s_2012_170				
Comment Code					
BU : Building					
Inspector Comment

Trees have grown and blocked the view of the building at the toe of the levee on the landward side. Fall 2015.

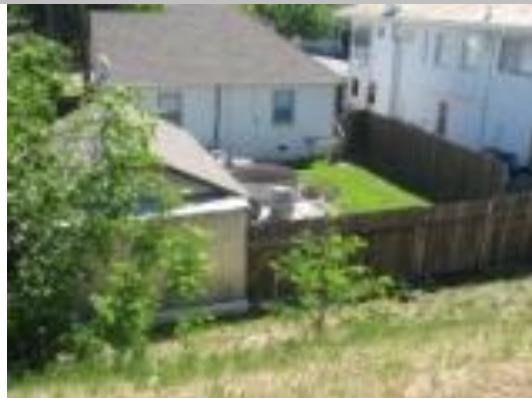
Photo 2 of 2 : FA\_2019\_MA0009\_201\_170\_20190904\_00098.jpg

LM Start	9.26	Rating **	M	Issue No.	170 (cont)	
LM End	9.26	Issue Type +	En	Location *	LS	
Category	Earthen Levee			GPS Latitude/Longitude		
				Start		End
Item	Encroachments			38.462653 °		38.462653 °
				-121.502670 °		-121.502670 °
DWR ID	DWR_MA0009_01_s_2012_170					
Comment Code						
BU : Building						
Inspector Comment

A building at the toe. Spring 2013

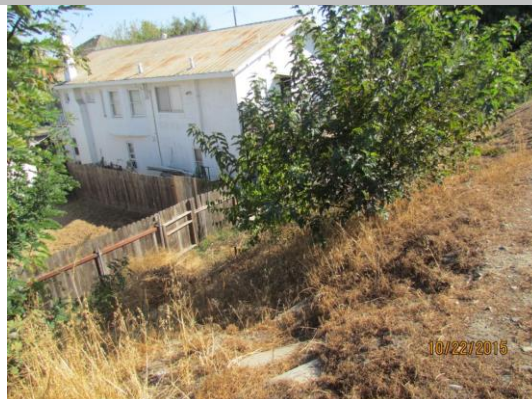
Photo 1 of 2 : FA\_2019\_MA0009\_201\_171\_20190904\_00099.jpg

LM Start	9.26	Rating **	U	Issue No.	171
LM End	9.26	Issue Type +	En	Location *	LS
Category	Earthen Levee			GPS Latitude/Longitude	
				Start	End
Item	Encroachments			38.462653 °	38.462653 °
				-121.502670 °	-121.502670 °
DWR ID	DWR_MA0009_01_s_2012_171				
Comment Code					
FE : Fence					
Inspector Comment

View of the fence at the toe of the levee on the landward side. Fall 2015.

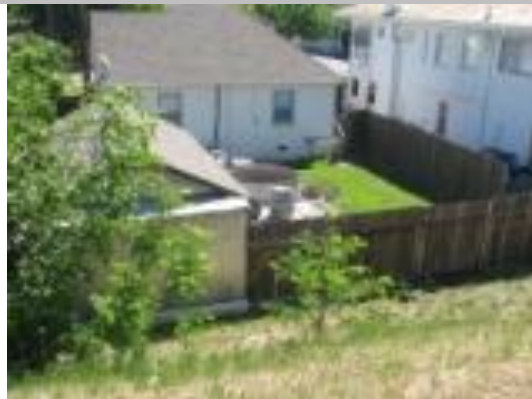
Photo 2 of 2 : FA\_2019\_MA0009\_201\_171\_20190904\_00100.jpg

A fence along the toe. Spring 2013

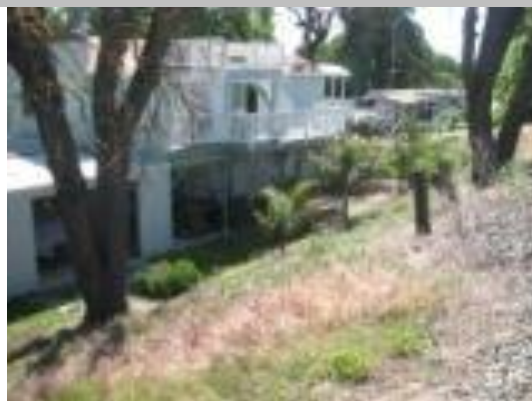
Photo 1 of 1 : FA\_2019\_MA0009\_201\_174\_20190904\_00104.jpg

LM Start	9.31	Rating **	M	Issue No.	174
LM End	9.31	Issue Type +	En	Location *	LS
Category	Earthen Levee			GPS Latitude/Longitude	
				Start	End
Item	Encroachments			38.462040 °	38.462040 °
				-121.502557 °	-121.502557 °
DWR ID	DWR_MA0009_01_s_2012_174				
Comment Code					
BU : Building					
Inspector Comment

A home is within the easement of the levee. Spring 2013

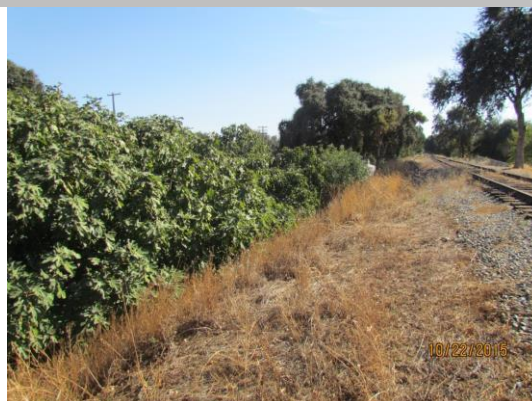
Photo 1 of 1 : FA\_2019\_MA0009\_201\_177\_20190904\_00107.jpg

LM Start	9.36	Rating **	M	Issue No.	177
LM End	9.36	Issue Type +	En	Location *	LS
Category	Earthen Levee			GPS Latitude/Longitude	
				Start	End
Item	Vegetation			38.461343 °	38.461343 °
				-121.502345 °	-121.502345 °
DWR ID	DWR_MA0009_01_s_2012_177				
Comment Code					
V6 : Landscaping					
Inspector Comment

View of the trees on the landward side of the levee looking downstream.  
Fall 2015.

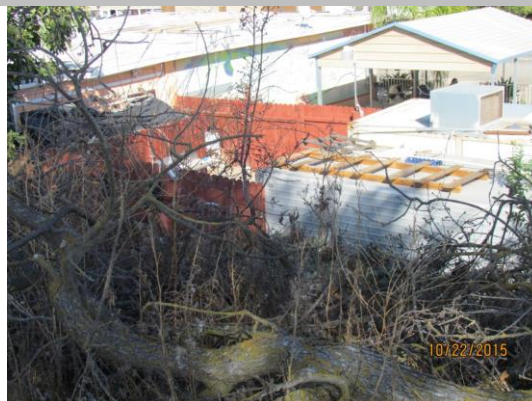
Photo 1 of 2 : FA\_2019\_MA0009\_201\_176\_20190904\_00105.jpg

LM Start	9.36	Rating **	M	Issue No.	176
LM End	9.36	Issue Type +	En	Location *	LS
Category	Earthen Levee			GPS Latitude/Longitude	
				Start	End
Item	Encroachments			38.461338 °	38.461338 °
				-121.502352 °	-121.502352 °
DWR ID	DWR_MA0009_01_s_2012_176				
Comment Code					
BU : Building					
Inspector Comment

View of the storage shed at the toe of the levee on the landward side.  
Fall 2015.

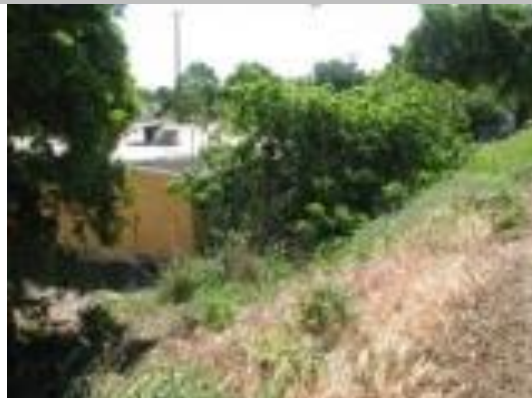
Photo 2 of 2 : FA\_2019\_MA0009\_201\_176\_20190904\_00106.jpg

LM Start	9.36	Rating **	M	Issue No.	176 (cont)	
LM End	9.36	Issue Type +	En	Location *	LS	
Category	Earthen Levee			GPS Latitude/Longitude		
				Start		End
Item	Encroachments			38.461338 °	38.461338 °	
				-121.502352 °	-121.502352 °	
DWR ID	DWR_MA0009_01_s _ 2012_176					
Comment Code						
BU : Building						
Inspector Comment

The building is at the toe of the levee. Spring 2013

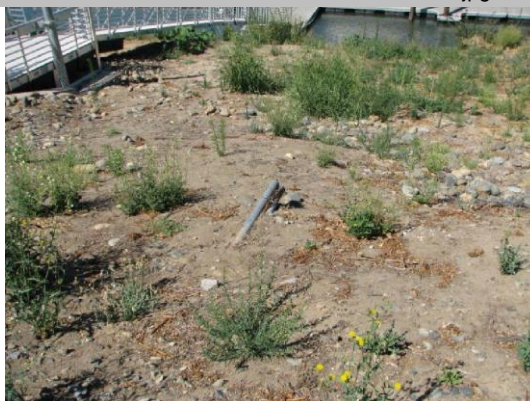
Photo 1 of 1 : UCIP\_FA\_2019\_5903\_8967.jpg

LM Start	9.39	Rating **	M	Issue No.	1795	
LM End	9.39	Issue Type +	En	Location *		
Category	Supplemental			GPS Latitude/Longitude		
				Start	End	
Item	DRAFT DWR UCIP Field Study			38.460920 °	38.460920 °	
				-121.502220 °	-121.502220 °	
DWR ID	18946					
Comment Code						
Inspector Comment						
DS_ID:18946						
FS_ID:5903						
EP_NO: N/A						
Repair Type: Non-Urgent						
Crossing Status: Found						
UCIP Comments: No permit identified for this crossing. Pipes should be removed or filled with grout.						
FIELD_STRUCT_DESC: 1 of 2: 2-inch galvanized steel pipe of an unknown purpose through the levee, 1.5 feet below the crown. Pipe open on both ends.						
FS Date: 6/21/2012 2:57:40 PM

View of pipe from WS shoulder looking towards river.

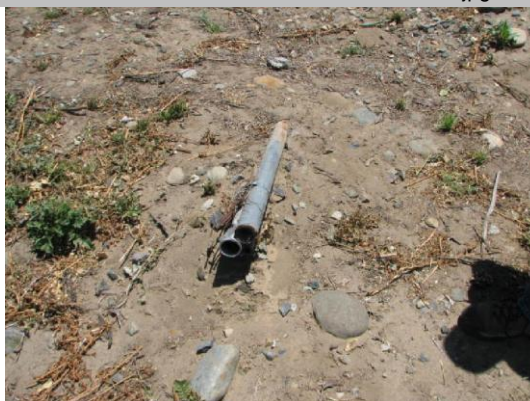
Photo 1 of 2 : UCIP\_FA\_2019\_5904\_8969.jpg

LM Start	9.39	Rating **	M	Issue No.	1796	
LM End	9.39	Issue Type +	En	Location *		
Category	Supplemental			GPS Latitude/Longitude		
				Start	End	
Item	DRAFT DWR UCIP Field Study			38.460920 °	38.460920 °	
				-121.502220 °	-121.502220 °	
DWR ID	18947					
Comment Code						
Inspector Comment						
DS_ID:18947						
FS_ID:5904						
EP_NO: N/A						
Repair Type: Non-Urgent						
Crossing Status: Found						
UCIP Comments: No permit identified for this crossing. Pipe should be removed or grouted in place.						
FIELD_STRUCT_DESC: 2 of 2: 2-inch galvanized steel pipe of an unknown purpose through the levee, 1.5 feet below the crown. Pipe open on both ends.						
FS Date: 6/21/2012

Pipe on WS shoulder.

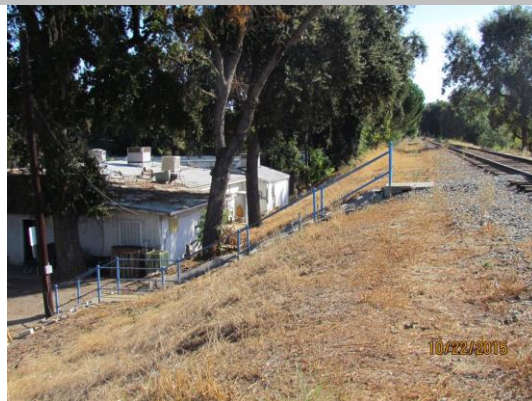
Photo 1 of 1 : FA\_2019\_MA0009\_201\_178\_20190904\_00108.jpg

LM Start	9.40	Rating **	M	Issue No.	178
LM End	9.40	Issue Type +	En	Location *	LS
Category	Earthen Levee			GPS Latitude/Longitude	
				Start	End
Item	Encroachments			38.460772 °	38.460772 °
				-121.502170 °	-121.502170 °
DWR ID	DWR_MA0009_01_s_2012_178				
Comment Code					
BU : Building					
Inspector Comment

View of the building within the easement on the landward side of the levee looking downstream. Fall 2015.

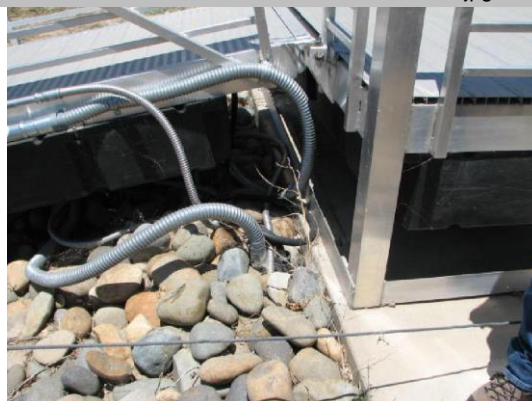
Photo 1 of 3 : UCIP\_FA\_2019\_5905\_8972.jpg

LM Start	9.40	Rating **	M	Issue No.	1797	
LM End	9.40	Issue Type +	En	Location *		
Category	Supplemental			GPS Latitude/Longitude		
				Start	End	
Item	DRAFT DWR UCIP Field Study			38.460670 °	38.460670 °	
				-121.502140 °	-121.502140 °	
DWR ID	18948					
Comment Code						
Inspector Comment						
DS_ID:18948						
FS_ID:5905						
EP_NO: N/A						
Repair Type: Non-Urgent						
Crossing Status: Found						
UCIP Comments: No permit identified for this crossing. Likely that this is a service line that provides power for the boat dock.						
FIELD_STRUCT_DESC: Christie box on the waterside (WS) shoulder.						
Possibly a utility crossing connecting to an electrical panel on the building at the landside (LS) toe. Pipe not visible.						
FS Date: 6/21/2012 3:04:17 PM

Likely that the pipes at the boat walkway cross at the christie box.

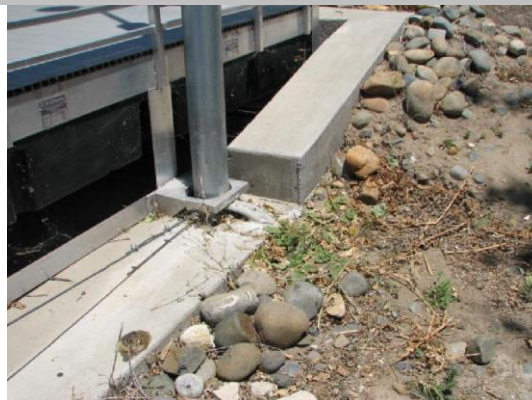
Photo 2 of 3 : UCIP\_FA\_2019\_5905\_8971.jpg

Likely that the pipes at the boat walkway cross at the christie box.

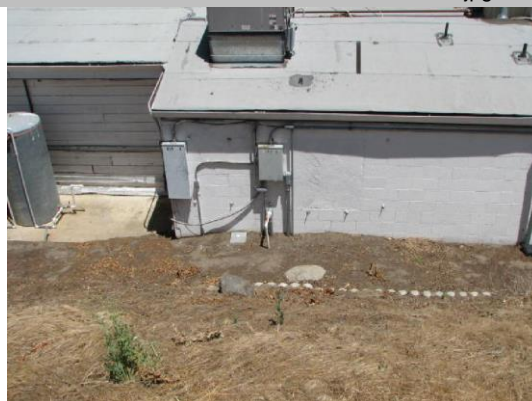
Photo 3 of 3 : UCIP\_FA\_2019\_5905\_8970.jpg

LM Start	9.40	Rating **	M	Issue No.	1797 (cont)	
LM End	9.40	Issue Type +	En	Location *		
Category	Supplemental			GPS Latitude/Longitude		
				Start	End	
Item	DRAFT DWR UCIP Field Study			38.460670 °	38.460670 °	
				-121.502140 °	-121.502140 °	
DWR ID	18948					
Comment Code						
Inspector Comment						
DS_ID:18948						
FS_ID:5905						
EP_NO: N/A						
Repair Type: Non-Urgent						
Crossing Status: Found						
UCIP Comments: No permit identified for this crossing. Likely that this is a service line that provides power for the boat dock.						
FIELD_STRUCT_DESC: Christie box on the waterside (WS) shoulder. Possibly a utility crossing connecting to an electrical panel on the building at the landside (LS) toe. Pipe not visible.						
FS Date: 6/21/2012 3:04:17 PM

Likely that the pipes at the fuse box on the LS toe building cross at the christie box to serve boat dock.

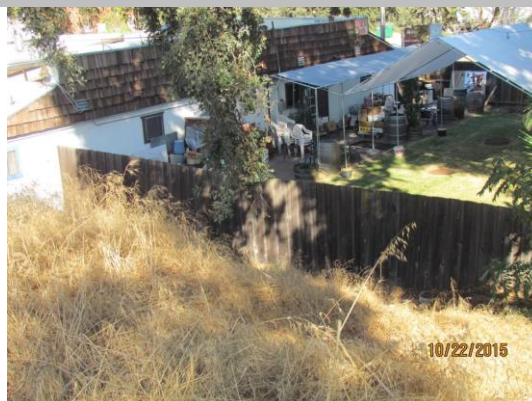
Photo 1 of 2 : FA\_2019\_MA0009\_201\_179\_20190904\_00109.jpg

LM Start	9.41	Rating **	U	Issue No.	179
LM End	9.41	Issue Type +	En	Location *	LS
Category	Earthen Levee			GPS Latitude/Longitude	
				Start	End
Item	Encroachments			38.460573 °	38.460573 °
				-121.502127 °	-121.502127 °
DWR ID	DWR_MA0009_01_s_2012_179				
Comment Code					
FE : Fence					
Inspector Comment

View of the fence on the landward side of the levee. Fall 2015.

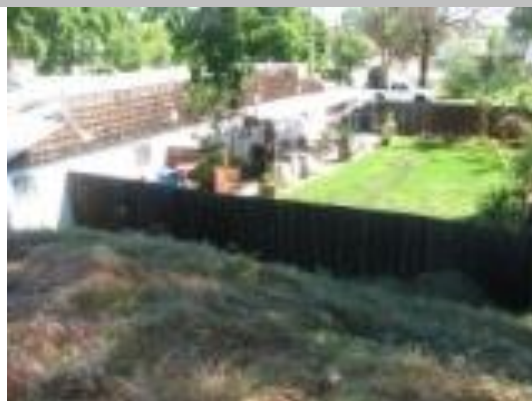
Photo 2 of 2 : FA\_2019\_MA0009\_201\_179\_20190904\_00110.jpg

LM Start	9.41	Rating **	U	Issue No.	179 (cont)	
LM End	9.41	Issue Type +	En	Location *	LS	
Category	Earthen Levee			GPS Latitude/Longitude		
				Start		End
Item	Encroachments			38.460573 °	38.460573 °	
				-121.502127 °	-121.502127 °	
DWR ID	DWR_MA0009_01_s_2012_179					
Comment Code						
FE : Fence						
Inspector Comment

The fence is at the toe of the levee. Spring 2013

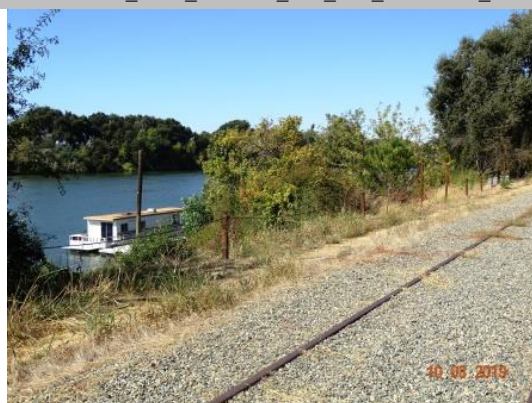
Photo 1 of 1 : FA\_2019\_MA0009\_201\_256\_20191008\_00540.jpg

LM Start	9.43	Rating **	M	Issue No.	256
LM End	9.46	Issue Type +	En	Location *	CR
Category	Earthen Levee			GPS Latitude/Longitude	
				Start	End
Item	Encroachments			38.460252 °	38.459907 °
				-121.502028 °	-121.501960 °
DWR ID	DWR_MA0009_01_f_2019_256				
Comment Code					
FE : Fence					
Inspector Comment					
Wooden posts with cable run along the waterside shoulder and do not appear to be authorized.

View of wooden posts with cables that run along the waterside shoulder. Fall 2019

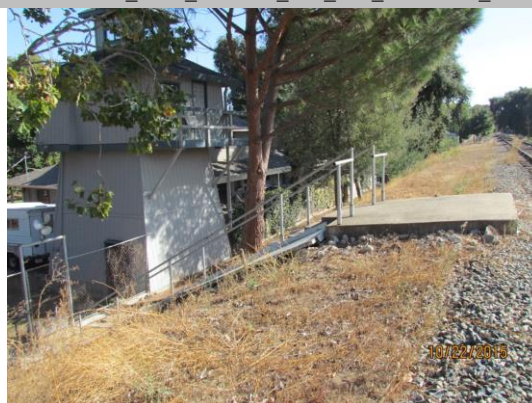
Photo 1 of 1 : FA\_2019\_MA0009\_201\_180\_20190904\_00111.jpg

LM Start	9.44	Rating **	M	Issue No.	180
LM End	9.44	Issue Type +	En	Location *	LS
Category	Earthen Levee			GPS Latitude/Longitude	
				Start	End
Item	Encroachments			38.460210 °	38.460210 °
				-121.502030 °	-121.502030 °
DWR ID	DWR_MA0009_01_s_2012_180				
Comment Code					
BU : Building					
Inspector Comment

View of the building within the easement on the landward side of the levee looking downstream. Fall 2015.

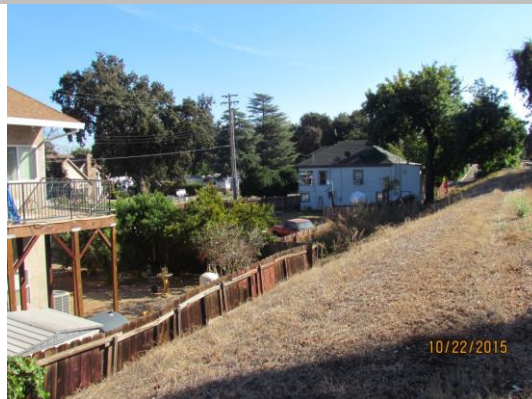
Photo 1 of 2 : FA\_2019\_MA0009\_201\_181\_20190904\_00112.jpg

LM Start	9.48	Rating **	U	Issue No.	181
LM End	9.52	Issue Type +	En	Location *	LS
Category	Earthen Levee			GPS Latitude/Longitude	
				Start	End
Item	Encroachments			38.459665 °	38.458993 °
				-121.501847 °	-121.501642 °
DWR ID	DWR_MA0009_01_s_2012_181				
Comment Code					
FE : Fence					
Inspector Comment

View of the fence along the toe of the levee on the landward side looking downstream. Fall 2015.

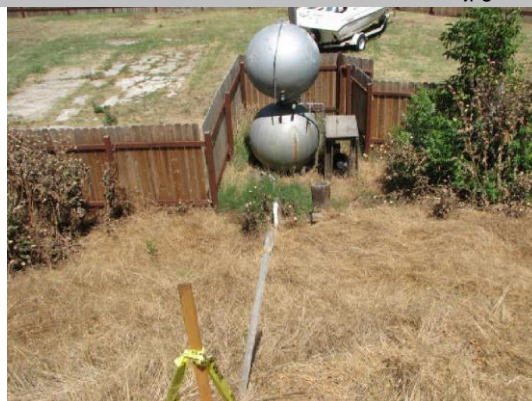
Photo 1 of 2 : UCIP\_FA\_2019\_5907\_8976.jpg

LM Start	9.52	Rating **	M	Issue No.	1798
LM End	9.52	Issue Type +	En	Location *	
Category	Supplemental			GPS Latitude/Longitude	
				Start	End
Item	DRAFT DWR UCIP Field Study			38.459110 °	38.459110 °
				-121.501660 °	-121.501660 °
DWR ID	18952				
Comment Code					
Inspector Comment					
DS_ID:18952 FS_ID:5907 EP_NO: N/A Repair Type: Non-Urgent Crossing Status: Found UCIP Comments: No permit identified for this crossing. FIELD_STRUCT_DESC: 2-inch polyvinyl chloride (PVC) water line through the levee, 3 feet below the crown. Pump and tank system on the landside (LS) toe. FS Date: 6/21/2012 3:12:50 PM

Pipe runs down LS slope to tank and pump at LS toe.

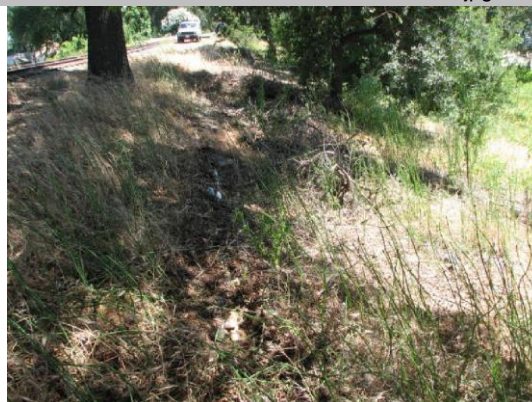
Photo 2 of 2 : UCIP\_FA\_2019\_5907\_8975.jpg

Pipe runs downstream parallel to levee crown just under the surface towards marina.

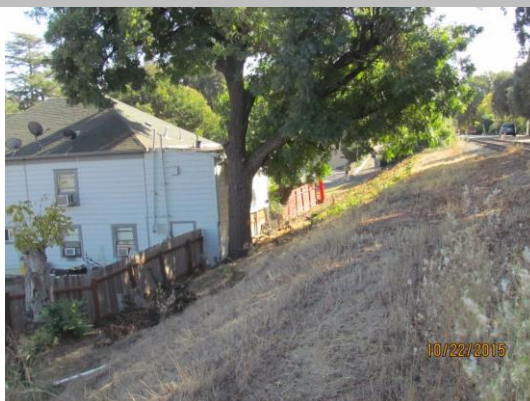
Photo 1 of 1 : FA\_2019\_MA0009\_201\_182\_20190904\_00114.jpg

LM Start	9.53	Rating **	M	Issue No.	182
LM End	9.53	Issue Type +	En	Location *	LS
Category	Earthen Levee			GPS Latitude/Longitude	
				Start	End
Item	Encroachments			38.458878 °	38.458878 °
				-121.501605 °	-121.501605 °
DWR ID	DWR_MA0009_01_s_2012_182				
Comment Code					
BU : Building					
Inspector Comment

View of the building at the toe of the levee on the landward side looking downstream. Fall 2015.

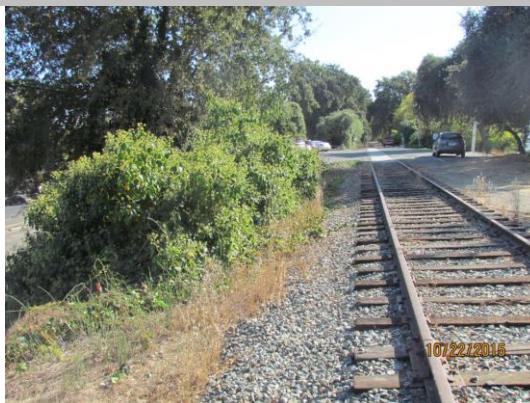
Photo 1 of 1 : FA\_2019\_MA0009\_201\_183\_20190904\_00115.jpg

LM Start	9.56	Rating **	M	Issue No.	183
LM End	9.58	Issue Type +	En	Location *	LS
Category	Earthen Levee			GPS Latitude/Longitude	
				Start	End
Item	Vegetation			38.458450 °	38.458220 °
				-121.501498 °	-121.501397 °
DWR ID	DWR_MA0009_01_s_2012_183				
Comment Code					
V6 : Landscaping					
Inspector Comment					
Clear bushes and tree growth over landside slope and shoulder.

View of the landscaping on the landward side of the levee looking downstream. Fall 2015.

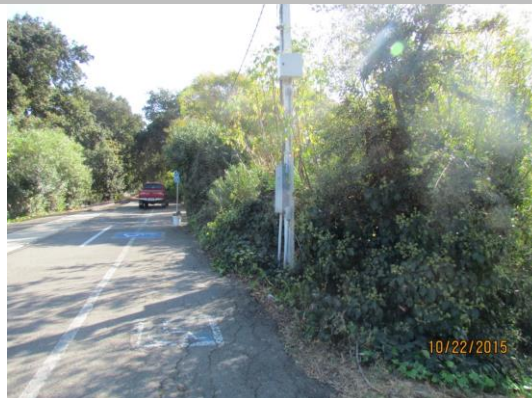
Photo 1 of 1 : FA\_2019\_MA0009\_201\_186\_20190904\_00120.jpg

LM Start	9.58	Rating **	U	Issue No.	186
LM End	9.59	Issue Type +	En	Location *	WS
Category	Earthen Levee			GPS Latitude/Longitude	
				Start	End
Item	Vegetation			38.458242°	38.458018°
				-121.501340°	-121.501317°
DWR ID	DWR_MA0009_01_s_2012_186				
Comment Code					
V6 : Landscaping					
Inspector Comment					
Trees and shrubs block visibility of levee slopes.

View of the trees and shrubs on the waterward side of the levee looking downstream. This is at the Freeport Marina. Fall 2015.

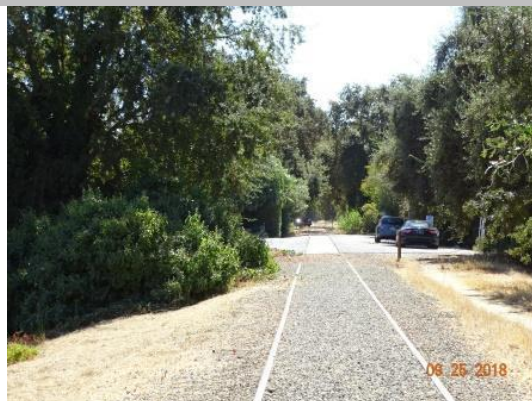
Photo 1 of 2 : FA\_2019\_MA0009\_201\_185\_20190904\_00118.jpg

LM Start	9.58	Rating **	U	Issue No.	185
LM End	9.60	Issue Type +	En	Location *	LS
Category	Earthen Levee			GPS Latitude/Longitude	
				Start	End
Item	Vegetation			38.458242 °	38.457873 °
				-121.501340 °	-121.501290 °
DWR ID	DWR_MA0009_01_s_2012_185				
Comment Code					
V6 : Landscaping					
Inspector Comment					
Shrubs need to be cleared.

View of shrubs on landside slope looking downstream. Fall 2018

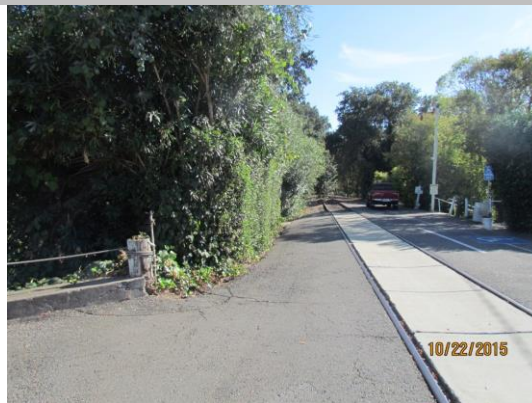
Photo 2 of 2 : FA\_2019\_MA0009\_201\_185\_20190904\_00119.jpg

View of the trees and shrubs on the landward side of the levee looking downstream. Fall 2015.

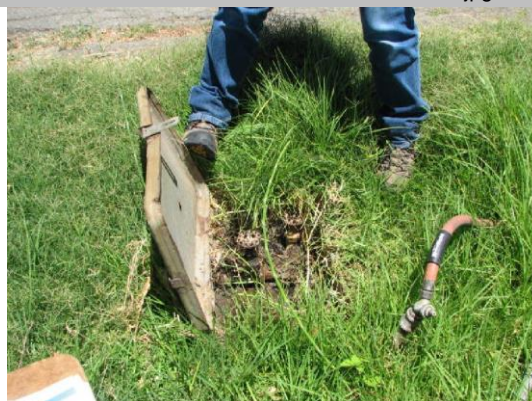
Photo 1 of 2 : UCIP\_FA\_2019\_5104\_6813.jpg

Comment Code						
Inspector Comment						
DS_ID:17397						
FS_ID:5104						
EP_NO: 5150						
Repair Type: Non-Urgent						
Crossing Status: Indicator Found						
UCIP Comments: There is no permit in this area for a waterline that could be identified. due to the amount of utilities in this area it is unclear if any are authorized.						
FIELD_STRUCT_DESC: 1 of 2: 1-1/2-inch pipe through levee, 1.0 foot below crown to boating facilities (Permit No's. 1573, 5150, and 5407). Appears to be 1.5-inch PVC waterline at this location. Aluminum box and cover on WS shoulder with valve and distribution header for sprinklers.						
FS Date: 6/21/2012 11:17:48 AM

Aluminum box and cover on ws shoulder with 1.5-inch waterline and valve.

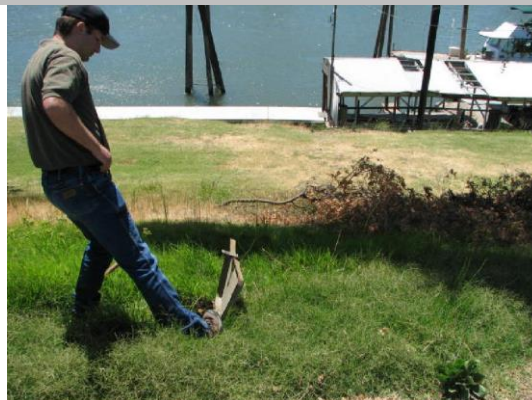
Photo 2 of 2 : UCIP\_FA\_2019\_5104\_6812.jpg

Access box on WS shoulder looking down ws slope.

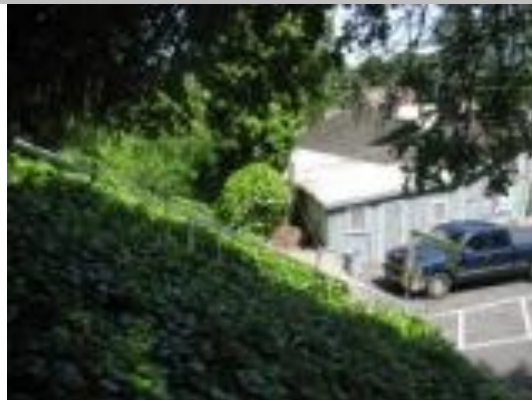
Photo 1 of 2 : FA\_2019\_MA0009\_201\_184\_20190904\_00116.jpg

LM Start	9.59	Rating **	M	Issue No.	184
LM End	9.59	Issue Type +	En	Location *	LS
Category	Earthen Levee			GPS Latitude/Longitude	
				Start	End
Item	Encroachments			38.458078 °	38.458078 °
				-121.501367 °	-121.501367 °
DWR ID	DWR_MA0009_01_f _ 2017_184				
Comment Code					
BU : Building					
Inspector Comment					
Freeport bait shop.

The Freeport Bait shop is at the toe of the levee. Photo taken spring 2012.

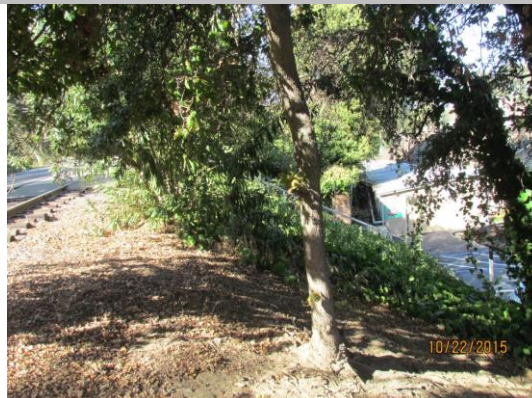
Photo 2 of 2 : FA\_2019\_MA0009\_201\_184\_20190904\_00117.jpg

LM Start	9.59	Rating **	M	Issue No.	184 (cont)	
LM End	9.59	Issue Type +	En	Location *	LS	
Category	Earthen Levee			GPS Latitude/Longitude		
				Start		End
Item	Encroachments			38.458078 °	38.458078 °	
				-121.501367 °	-121.501367 °	
DWR ID	DWR_MA0009_01_f_2017_184					
Comment Code						
BU : Building						
Inspector Comment						
Freeport bait shop.

View of the Freeport Bait shop at the toe of the levee on the landward side looking upstream. Fall 2015.

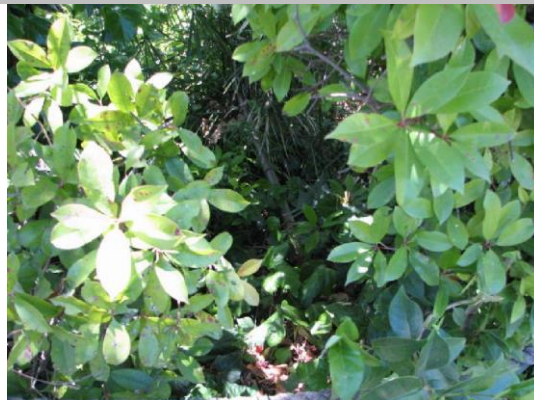
Photo 2 of 3 : UCIP\_FA\_2019\_5908\_8978.jpg

LM Start	9.59	Rating **	M	Issue No.	1801 (cont)	
LM End	9.59	Issue Type +	En	Location *		
Category	Supplemental			GPS Latitude/Longitude		
				Start	End	
Item	DRAFT DWR UCIP Field Study			38.458050 °	38.458050 °	
				-121.501330 °	-121.501330 °	
DWR ID	18949					
Comment Code						
Inspector Comment						
DS_ID:18949 FS_ID:5908 EP_NO: N/A Repair Type: Non-Urgent Crossing Status: Found UCIP Comments: No permit identified for this crossing. FIELD_STRUCT_DESC: 1.5-inch galvanized steel pipe of an unknown purpose through the levee, 1.5 feet below the crown. FS Date: 6/21/2012 3:17:41 PM

View of pipe on WS slope.

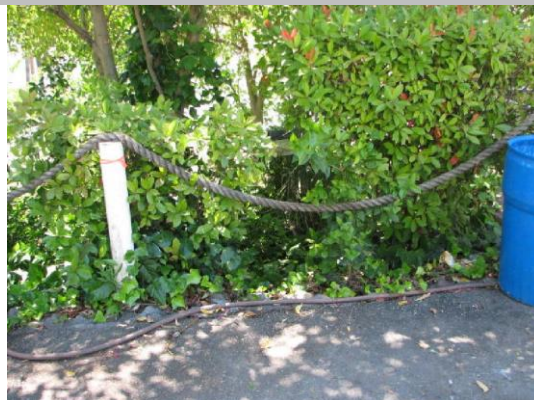
Photo 3 of 3 : UCIP\_FA\_2019\_5908\_8977.jpg

View of pipe location from levee crown looking towards WS slope.

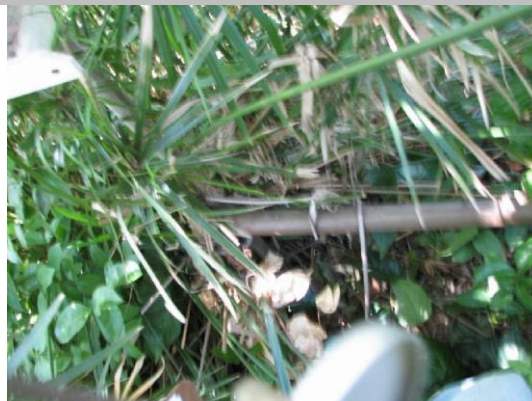
Photo 1 of 3 : UCIP\_FA\_2019\_5107\_6816.jpg

LM Start	9.59	Rating **	M	Issue No.	1803
LM End	9.59	Issue Type +	En	Location *	
Category	Supplemental			GPS Latitude/Longitude	
				Start	End
Item	DRAFT DWR UCIP Field Study			38.458010 °	38.458010 °
				-121.501320 °	-121.501320 °
DWR ID	17646				
Comment Code					
Inspector Comment					
DS_ID:17646 FS_ID:5107 EP_NO: N/A Repair Type: Non-Urgent Crossing Status: Found UCIP Comments: Due to the amount of utilities in this area it is unclear if any are authorized. This area needs to be cleared of vegetation and thoroughly searched for utility crossings. FIELD_STRUCT_DESC: 2 of 6: 2-inch drain pipe through levee, 3 feet below crown. Main valve in box on waterward slope. Found 1.5-inch steel pipe near this location just upstream of stairs on WS of levee 1.5 feet below crown. FS Date: 6/21/2012 12:59:07 PM

Pipe on WS slope just upstream from stairs.

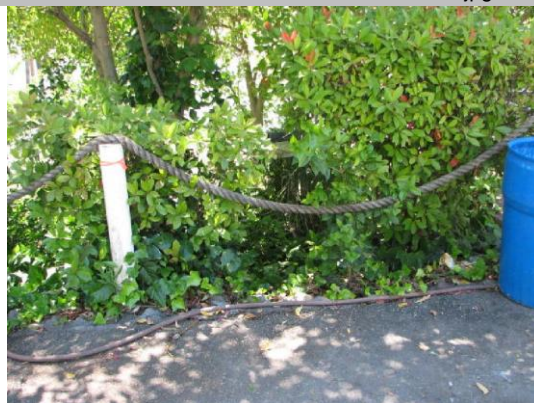
Photo 3 of 3 : UCIP\_FA\_2019\_5107\_6814.jpg

LM Start	9.59	Rating **	M	Issue No.	1803 (cont)	
LM End	9.59	Issue Type +	En	Location *		
Category	Supplemental			GPS Latitude/Longitude		
				Start	End	
Item	DRAFT DWR UCIP Field Study			38.458010 °	38.458010 °	
				-121.501320 °	-121.501320 °	
DWR ID	17646					
Comment Code						
Inspector Comment						
DS_ID:17646 FS_ID:5107 EP_NO: N/A Repair Type: Non-Urgent Crossing Status: Found UCIP Comments: Due to the amount of utilities in this area it is unclear if any are authorized. This area needs to be cleared of vegetation and thoroughly searched for utility crossings. FIELD_STRUCT_DESC: 2 of 6: 2-inch drain pipe through levee, 3 feet below crown. Main valve in box on waterward slope. Found 1.5-inch steel pipe near this location just upstream of stairs on WS of levee 1.5 feet below crown. FS Date: 6/21/2012 12:59:07 PM

Pipe on WS slope just upstream from stairs.

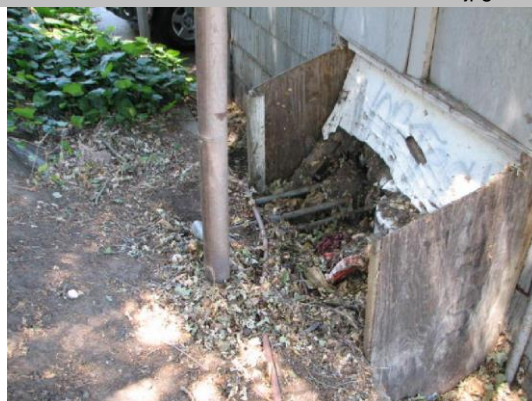
Photo 1 of 1 : UCIP\_FA\_2019\_5108\_6817.jpg

Comment Code						
Inspector Comment						
DS_ID:17647						
FS_ID:5108						
EP_NO: N/A						
Repair Type: Non-Urgent						
Crossing Status: Indicator Found						
UCIP Comments: Due to the amount of utilities in this area it is unclear if any are authorized. This area needs to be cleared of vegetation and thoroughly searched for utility crossings.						
FIELD_STRUCT_DESC: 3 of 6: 1-inch pipe of an unknown material or purpose possibly through the levee, 0.5 feet below the crown. Pipe goes to marina in stream. Pipe visible at the back of the shed at the landside (LS) toe. Unclear if this pipe goes through the levee. [Additional Reference(s): DWR Levee Log, 1991].						
FS Date: 6/21/2012 1:03:36 PM

Pipes appear to be exiting the back of the shed and going through the levee at the LS toe.

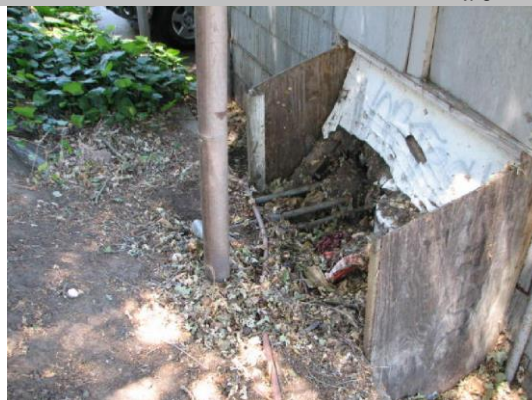
Photo 1 of 1 : UCIP\_FA\_2019\_5109\_6818.jpg

Comment Code						
Inspector Comment						
DS_ID:17648						
FS_ID:5109						
EP_NO: N/A						
Repair Type: Non-Urgent						
Crossing Status: Indicator Found						
UCIP Comments: Due to the amount of utilities in this area it is unclear if any are authorized. This area needs to be cleared of vegetation and thoroughly searched for utility crossings.						
FIELD_STRUCT_DESC: 4 of 6: 1-inch pipe of an unknown material or purpose through the levee, 0.5 feet below the crown. Pipe goes to marina in stream. Pipe appears to exit the back of the shed and enter the levee at the landside (LS) toe. [Additional Reference(s): DWR Levee Log, 1991].						
FS Date: 6/21/2012 1:07:06 PM

Pipes appear to exit the back of the shed and enter the levee.

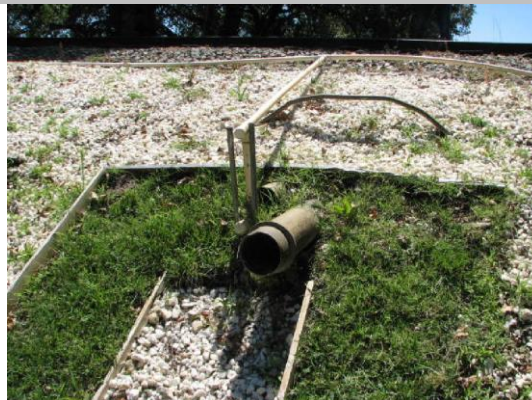
Photo 1 of 3 : UCIP\_FA\_2019\_53470\_20793.jpg

DS\_ID:18950  
FS\_ID:53470  
EP\_NO: N/A  
Repair Type: Non-Urgent  
Crossing Status: Found  
UCIP Comments: 08/24/2018 Same as last inspection. Pipe open on both ends. Dense vegetation on the WS prevents access to WS outlet. Should contact owner to determine status. Crossing appears to be above freeboard. Recommend downgrading this crossing to "Non-Urgent" because no integrity issues were observed on the levee or the pipe. (A. McDonald - DWR UCIP)12/01/2016 same as last inspection conduit is open through the levee. Unable to locate WS daylight due to dense vegetation. Need to contact owner to determine status of crossing. If crossing is abandoned, owner will need to coordinate with the CVFPB to comply with Title 23. (O. Magana - DWR UCIP)06/21/2012 Open conduit through the levee. No permit identified for this crossing. (W. Wylie - DWR UCIP)  
FIELD\_STRUCT\_DESC: 1 of 2: 5-inch galvanized steel water pipe through the levee, 3 feet below the crown. Pipe open on both ends.

Pipe through freeport marina grass sign.

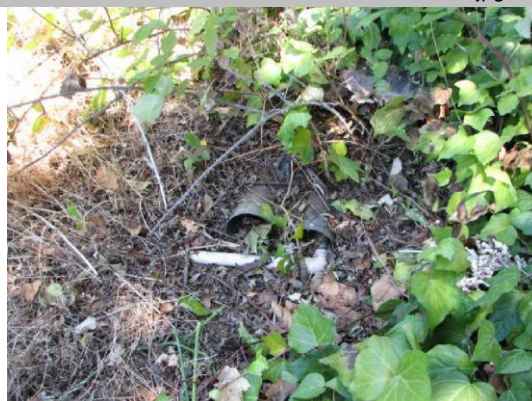
Photo 3 of 3 : UCIP\_FA\_2019\_53470\_20791.jpg

Comment Code						
Inspector Comment						
DS_ID:18950 FS_ID:53470 EP_NO: N/A Repair Type: Non-Urgent Crossing Status: Found UCIP Comments: 08/24/2018 Same as last inspection. Pipe open on both ends. Dense vegetation on the WS prevents access to WS outlet. Should contact owner to determine status. Crossing appears to be above freeboard. Recommend downgrading this crossing to "Non-Urgent" because no integrity issues were observed on the levee or the pipe. (A. McDonald - DWR UCIP)12/01/2016 same as last inspection conduit is open through the levee. Unable to locate WS daylight due to dense vegetation. Need to contact owner to determine status of crossing. If crossing is abandoned, owner will need to coordinate with the CVFPB to comply with Title 23. (O. Magana - DWR UCIP)06/21/2012 Open conduit through the levee. No permit identified for this crossing. (W. Wylie - DWR UCIP) FIELD_STRUCT_DESC: 1 of 2: 5-inch galvanized steel water pipe through the levee, 3 feet below the crown. Pipe open on both ends. FS Date: 8/24/2018

Both pipes on WS shoulder.

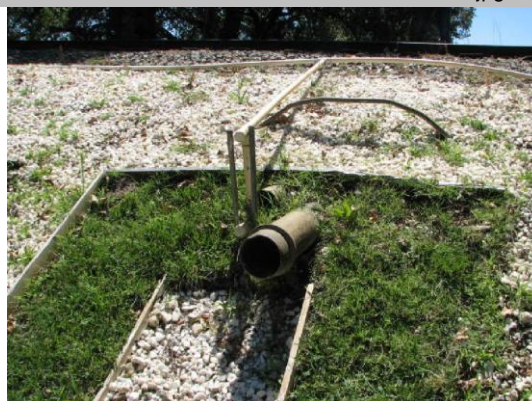
Photo 1 of 3 : UCIP\_FA\_2019\_53471\_20796.jpg

Comment Code						
Inspector Comment						
DS_ID:18951 FS_ID:53471 EP_NO: N/A Repair Type: Non-Urgent Crossing Status: Found UCIP Comments: 08/24/2018 Same as last inspection. Pipe open on both ends. Dense vegetation on the WS prevents access to WS outlet. Should contact owner to determine status. Crossing appears to be above freeboard. Recommend downgrading this crossing to "Non-Urgent" because no integrity issues were observed on the levee or the pipe. (A. McDonald - DWR UCIP)12/02/2016 same as last inspection conduit is open through the levee. Unable to locate WS daylight due to dense vegetation. Need to contact owner to determine status of crossing. If crossing is abandoned, owner will need to coordinate with the CVFPB to comply with Title 23. (O. Magana - DWR UCIP)06/21/2012 Pipe open on both ends. No permit identified for this crossing. (W. Wylie - DWR UCIP) FIELD_STRUCT_DESC: 2 of 2: 5-inch galvanized steel water pipe through the levee, 3 feet below the crown. Pipe open on both ends. FS Date: 8/24/2018

Both pipes through grass sign on LS slope.

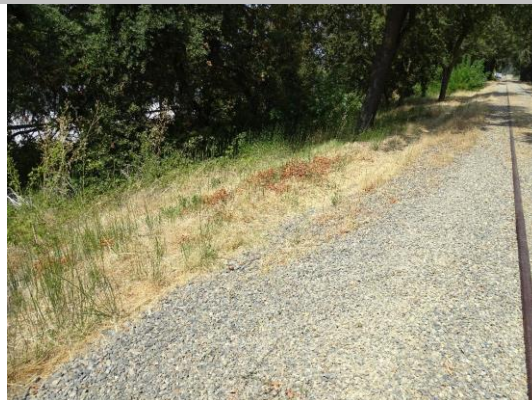
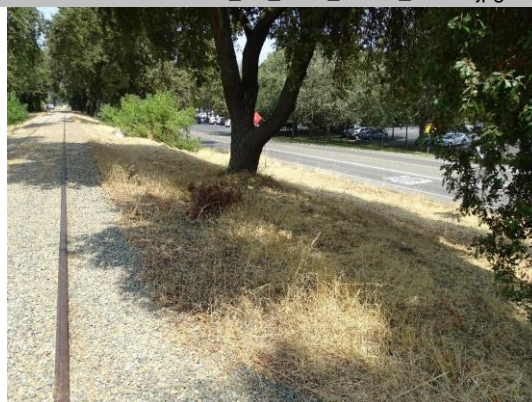
Comment Code					
Inspector Comment					
DS_ID:17399 FS_ID:53472 EP_NO: 1804 Repair Type: Non-Urgent Crossing Status: Not Found UCIP Comments: 08/24/2018 Same as last inspection. No markers were found. Pipeline is under the surface for the entire crossing. Crossing has been downgraded to "Non-Urgent" because there are no integrity issues with the levee or the pipeline. Supporting documentation that this pipe is in good working order would downgrade this crossing to "No Action Needed." (A. McDonald - DWR UCIP)12/02/2016 same as last inspection no markers were found at this location. Need to coordinate with owner to determine status of crossing. (O. Magana - DWR UCIP)06/22/2012 No evidence could be found of crossing. Gasline markers should be installed if pipe actually at this location. Pipe not found. (W. Wylie - DWR UCIP) FIELD_STRUCT_DESC: 1 of 2: 1.5-inch galvanized iron natural gas pipeline and a 1-inch electrical conduit and cable through the levee, at not more than 3 feet below the crown. Protected by metal fin cutoff wall. Pipe and cable to be under the surface for the entire crossing. Shutoff valves on both ends. (1.5-inch gas line authorized under Permit No. 1804, 1959 - Cofer). [Additional Reference(s): DWR Levee Log, 1991]. FS Date: 8/24/2018

WS view.

LS view.

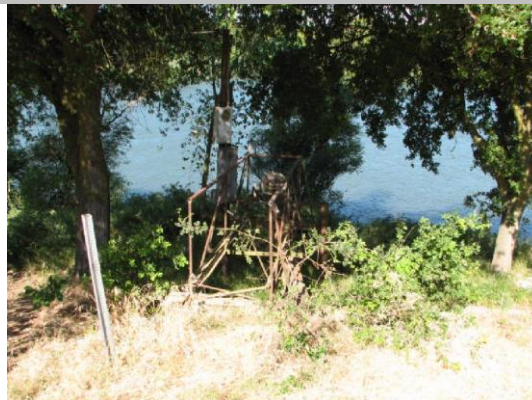
Photo 1 of 3 : UCIP\_FA\_2019\_5117\_6830.jpg

LM Start	9.80	Rating **	M	Issue No.	1811
LM End	9.80	Issue Type +	En	Location *	
Category	Supplemental			GPS Latitude/Longitude	
				Start	End
Item	DRAFT DWR UCIP Field Study			38.455040 °	38.455040 °
				-121.500450 °	-121.500450 °
DWR ID	17439				
Comment Code					
Inspector Comment					
DS_ID:17439					
FS_ID:5117					
EP_NO: N/A					
Repair Type: Non-Urgent					
Crossing Status: Found					
UCIP Comments: Walkway unsafe and could pose attractive nuisance to minors. Walkway should be repaired or removed.					
FIELD_STRUCT_DESC: 14-inch pipe through levee, 7.2 feet below crown. Pump on pile structure in stream. Overhead power line crosses levee to pole and meter next to pump. Ramp on landward slope. Permit No. 1449, 1949. Included in O+M manual (1955).					
FS Date: 6/22/2012 1:36:29 PM

Walkway in total disrepair at pump on WS.

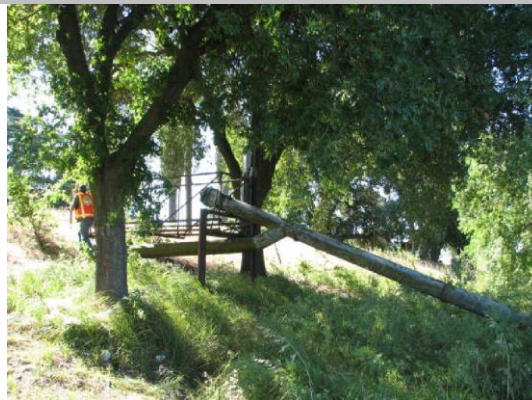
Photo 3 of 3 : UCIP\_FA\_2019\_5117\_6828.jpg

LM Start	9.80	Rating **	M	Issue No.	1811 (cont)	
LM End	9.80	Issue Type +	En	Location *		
Category	Supplemental			GPS Latitude/Longitude		
				Start	End	
Item	DRAFT DWR UCIP Field Study			38.455040 °	38.455040 °	
				-121.500450 °	-121.500450 °	
DWR ID	17439					
Comment Code						
Inspector Comment						
DS_ID:17439						
FS_ID:5117						
EP_NO: N/A						
Repair Type: Non-Urgent						
Crossing Status: Found						
UCIP Comments: Walkway unsafe and could pose attractive nuisance to minors. Walkway should be repaired or removed.						
FIELD_STRUCT_DESC: 14-inch pipe through levee, 7.2 feet below crown. Pump on pile structure in stream. Overhead power line crosses levee to pole and meter next to pump. Ramp on landward slope. Permit No. 1449, 1949. Included in O+M manual (1955).						
FS Date: 6/22/2012 1:36:29 PM

Pump and pipe on WS of levee.

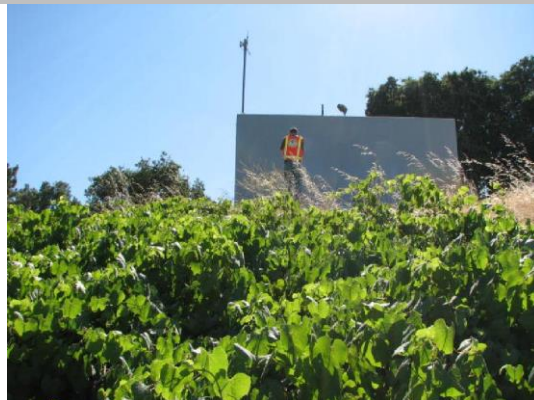
Photo 1 of 2 : UCIP\_FA\_2019\_5920\_9002.jpg

LM Start	9.85	Rating **	M	Issue No.	1812
LM End	9.85	Issue Type +	En	Location *	
Category	Supplemental			GPS Latitude/Longitude	
				Start	End
Item	DRAFT DWR UCIP Field Study			38.454360 °	38.454360 °
				-121.500300 °	-121.500300 °
DWR ID	18953				
Comment Code					
Inspector Comment					
DS_ID:18953					
FS_ID:5920					
EP_NO: N/A					
Repair Type: Non-Urgent					
Crossing Status: Found					
UCIP Comments: No permit identified for this crossing.					
FIELD_STRUCT_DESC: 2-inch polyvinyl chloride (PVC) pipe of an unknown purpose found on the waterside (WS) toe. Unclear if pipe penetrates the levee.					
FS Date: 6/22/2012 3:33:20 PM

Pipe alignment from waters edge to upstream corner of building on WS shoulder of levee.

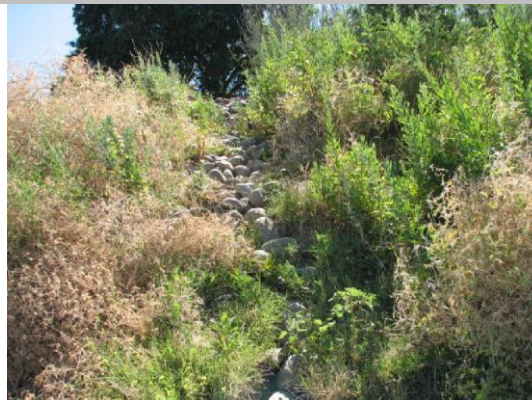
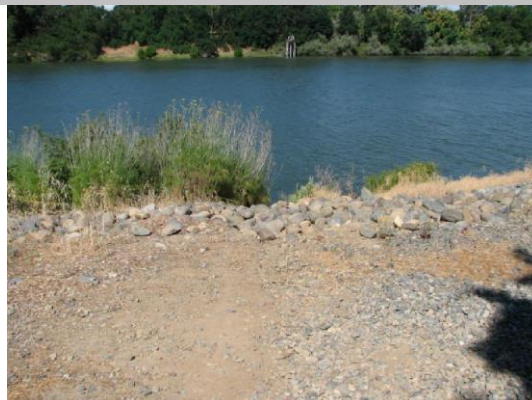
LM Start	9.86	Rating **	M	Issue No.	1813	
LM End	9.86	Issue Type +	En	Location *		
Category	Supplemental			GPS Latitude/Longitude		
				Start		End
Item	DRAFT DWR UCIP Field Study			38.454220 °		38.454220 °
				-121.500280 °		-121.500280 °
DWR ID	18954					
Comment Code						
Inspector Comment						
DS_ID:18954 FS_ID:5921 EP_NO: N/A Repair Type: Non-Urgent Crossing Status: Indicator Found UCIP Comments: No permit identified for this crossing. FIELD_STRUCT_DESC: Trench work through the levee. Evidence of unidentified utility crossing. FS Date: 6/22/2012 3:38:59 PM

Trench work down WS slope.

Trench work from under RR tracks accross crown down WS slope.

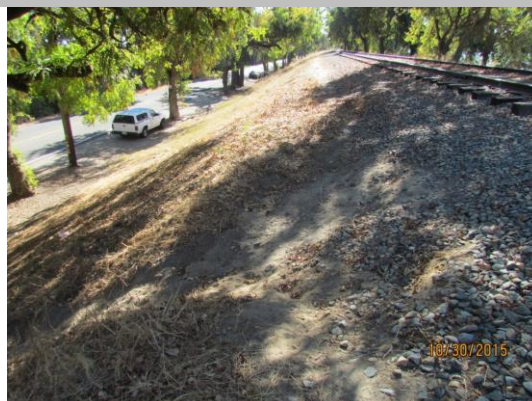
Photo 2 of 2 : FA\_2019\_MA0009\_201\_361\_20190904\_00256.jpg

LM Start	9.94	Rating **	A/W	Issue No.	361 (cont)	
LM End	9.94	Issue Type +	Ma	Location *	LS	
Category	Earthen Levee			GPS Latitude/Longitude		
				Start		End
Item	Slope Stability			38.453095 °		38.453095 °
				-121.500147 °		-121.500147 °
DWR ID	DWR_MA0009_01_f_2015_361					
Comment Code						
S2 : Repair the levee slope damaged by foot traffic and prevent access where possible.						
Inspector Comment

View of the slope stability on the landward side of the levee looking downstream. Fall 2015.

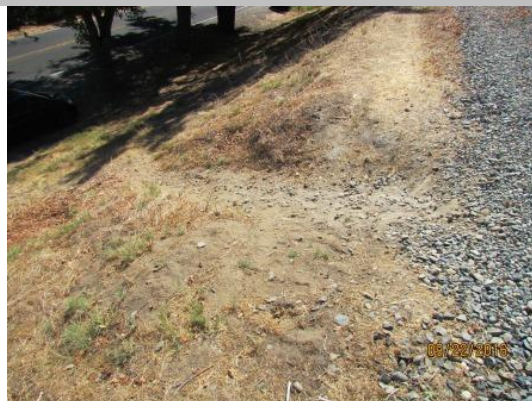
Photo 1 of 2 : FA\_2019\_MA0009\_201\_362\_20190904\_00257.jpg

LM Start	9.96	Rating **	A/W	Issue No.	362
LM End	9.96	Issue Type +	Ma	Location *	LS
Category	Earthen Levee			GPS Latitude/Longitude	
				Start	End
Item	Slope Stability			38.452728 °	38.452728 °
				-121.500100 °	-121.500100 °
DWR ID	DWR_MA0009_01_f_2015_362				
Comment Code					
S2 : Repair the levee slope damaged by foot traffic and prevent access where possible.					
Inspector Comment

Updated view of a footpath on LS slope of the levee. Fall 2016.

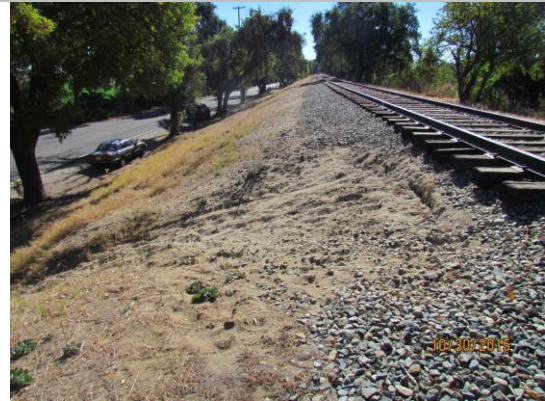
Photo 1 of 1 : FA\_2019\_MA0009\_201\_365\_20190904\_00259.jpg

View of the slope stability on the landward side of the levee looking downstream. Fall 2015.

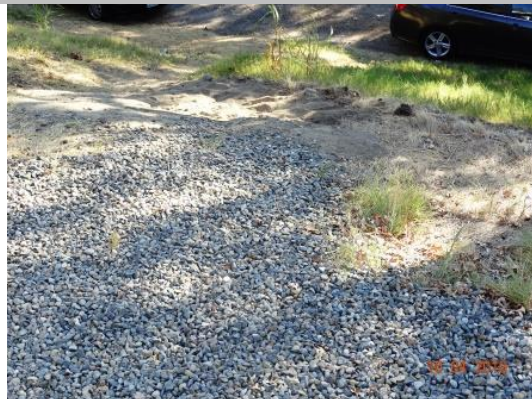
Photo 1 of 1 : FA\_2019\_MA0009\_201\_381\_20191010\_00542.jpg

LM Start	10.12	Rating **	A/W	Issue No.	381
LM End	10.12	Issue Type +	Ma	Location *	LS
Category	Earthen Levee			GPS Latitude/Longitude	
				Start	End
Item	Slope Stability			38.450427 °	38.450427 °
				-121.500032 °	-121.500032 °
DWR ID	DWR_MA0009_01_s_2016_381				
Comment Code					
S3 : Repair the levee slope damaged by vehicle traffic and prevent access where possible.					
Inspector Comment

View of footpath damage on landside slope that was mitigated with gravel. Fall 2019
